Original Paper

## STRATEGIES FOR MANGROVE REHABILITATION IN AN ERODED COASTLINE OF SELANGOR, PENINSULAR MALAYSIA

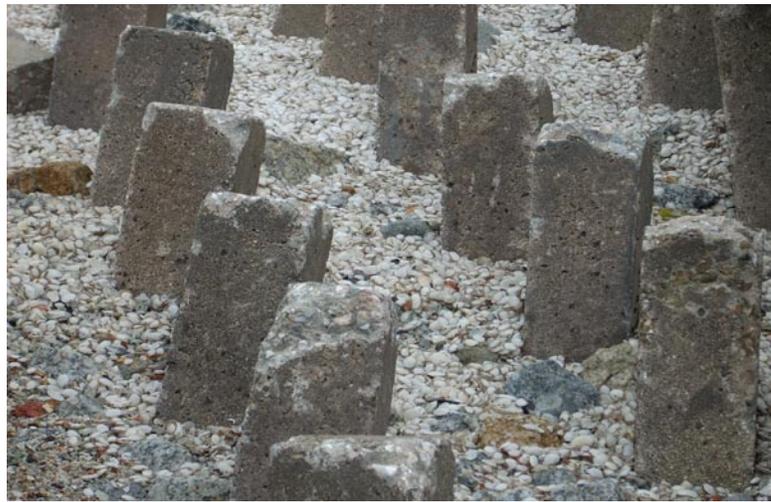
Fig 4. Photograph showing the calcareous deposits on the shore and revetment indicating current erosion and littoral drift

There is a site specific erosion and deposition occurring along the Sg. Hj Dorani coast due to construction of resort and installation of engineering structures like Geo Textile Tubes and L Block Breakwater. After the construction of breakwater in May 2008, the sediment accretion is  $\pm 0.0037$ cm per annum which is considerably negligible in dynamic patches (Kamali, Personal communication) in mud flat where plantation is carried out (Fig 7&7a). The presence of the large grain size shell hash along the coast indicates that the shoreline is still experiencing some major wave and current erosion. The area prior to the breakwaters being installed

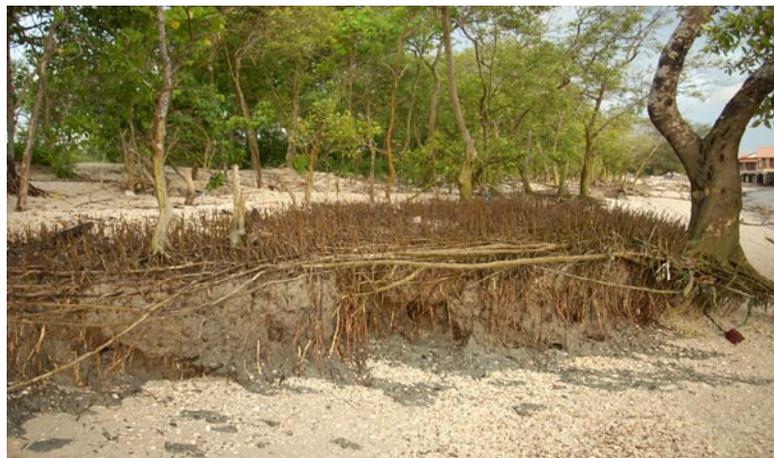
**Fig. 5** Photograph showing the effect of coastal erosion on the fringe mangroves – the reference forest patch available to understand the natural vegetation profile is at the verge of extinction

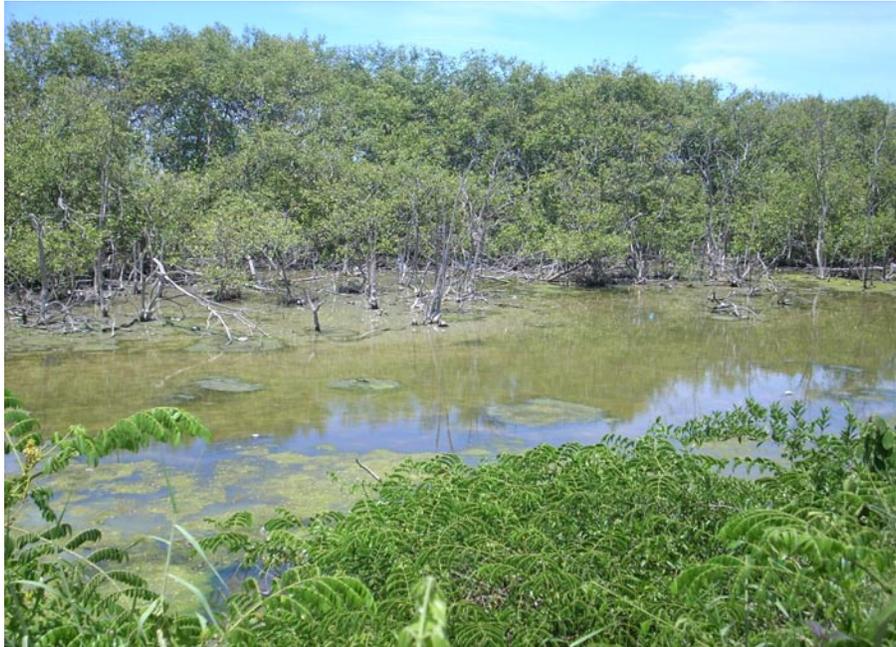
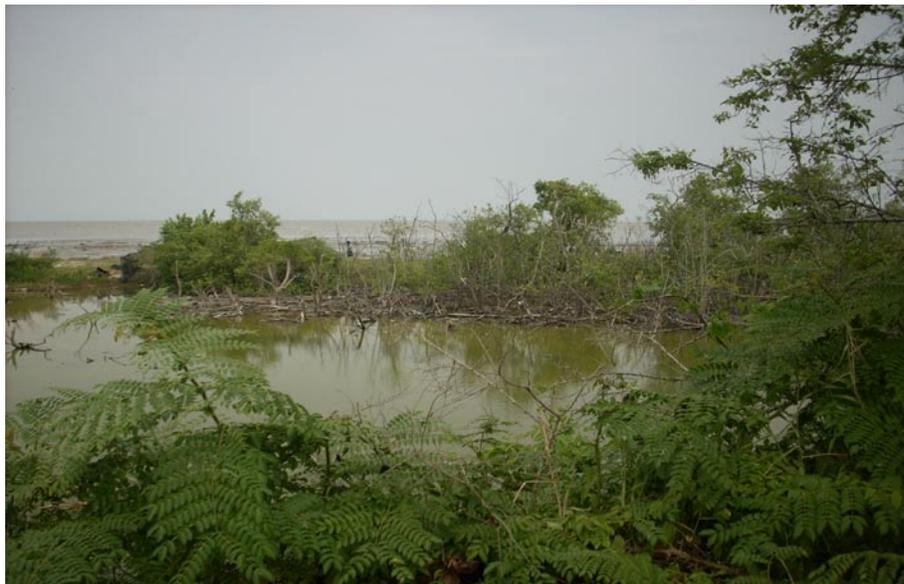
**Fig. 6.** Photograph showing the water-logging, drying and loss of mangroves in June 2009 in front of FRIM's mangrove plantation site substantiating ignorance to conserve existing mangroves

There is no outlet for the water to drain from mangroves and hence the mangroves are dying. The fate of the existing mangroves, the speed of degradation and ignorance or negligence in conserving the existing natural resource is substantiated in the Figures 6&6a. Unless the hydrology of that area is restored there will not be any mangroves in near future either to protect the shoreline or to provide seeds for future forest establishment. Differential survival and growth of mangrove species studied to date are related to the depth, duration and frequency of flooding and soil saturation (Nickerson and Thibodeau (1985), McKee and Mendelssohn (1988), McKee (1993), McKee (1995), and McKee and Faulkner (2000a, b) . Ultimately, the critical periods of inundation and dryness govern the health of the forest (Kjerfve, 1990). For these reasons, any engineering works constructed near mangrove forests, or in the watershed that drains to mangroves, must be designed to allow for sufficient free exchange of seawater with the adjacent ocean or estuary, and not interrupt essential upland or riverine drainage into the mangrove forest. Failure to properly account for these essential inputs and exchange of water will result in stress and possible death of the forest.

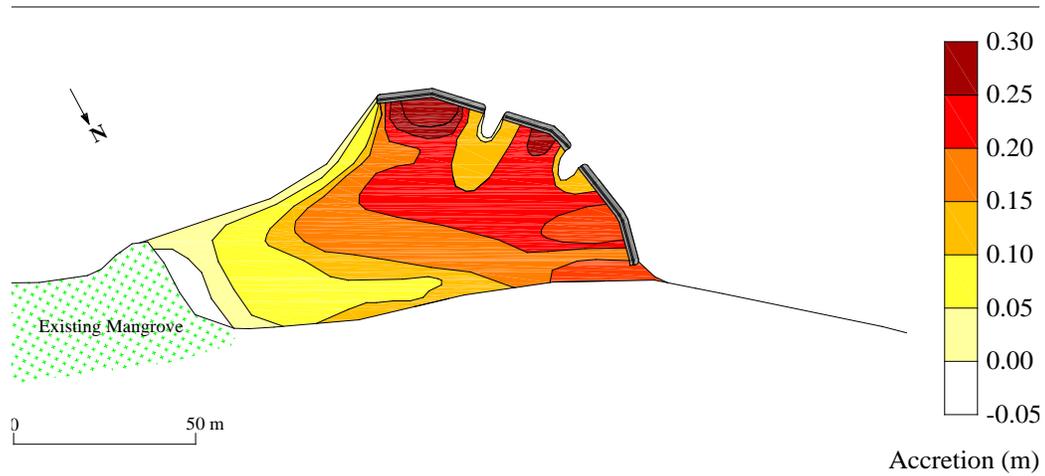
**Fig 7.** Rate of Sediment accretion at the mangrove plantation site in October 2008, 4<sup>th</sup> month after construction of L Block Break water

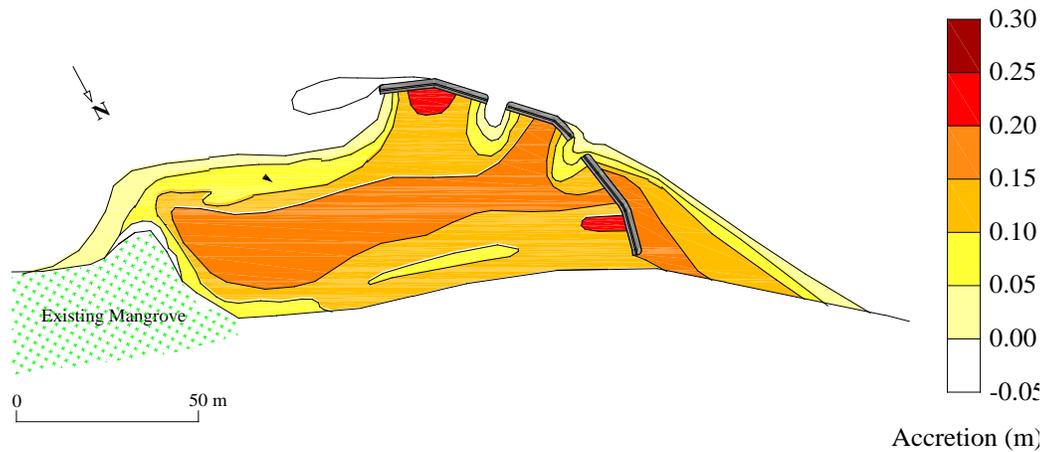
**Fig 7.a.** Rate of Sediment accretion at the mangrove plantation site in February 2009, 8<sup>th</sup> month after construction of L Block Break
